Township of
Langley

Water Quality Report 2014

Prepared by:
Tara Macrae
Engineering Technologist III
Water Resources and Environment
Township of Langley

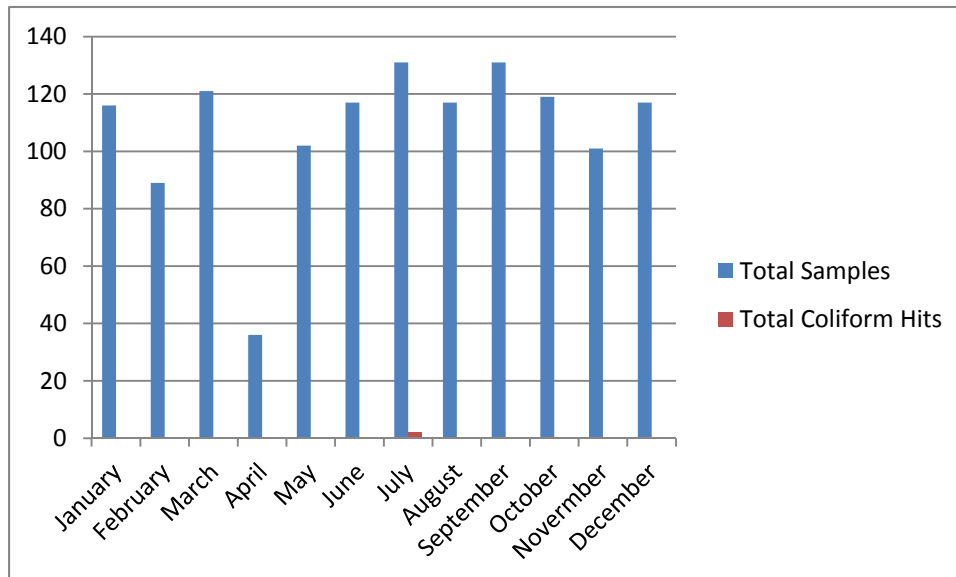
Figure 5.2.1 Comparison of Total Coliform Positive Results to Total Samples Tested

The cause of the original positives can be attributed to contamination of the sample bottles, equipment, or laboratory error. Sampling and equipment handling methods are reviewed by samplers annually to help maintain sterility.

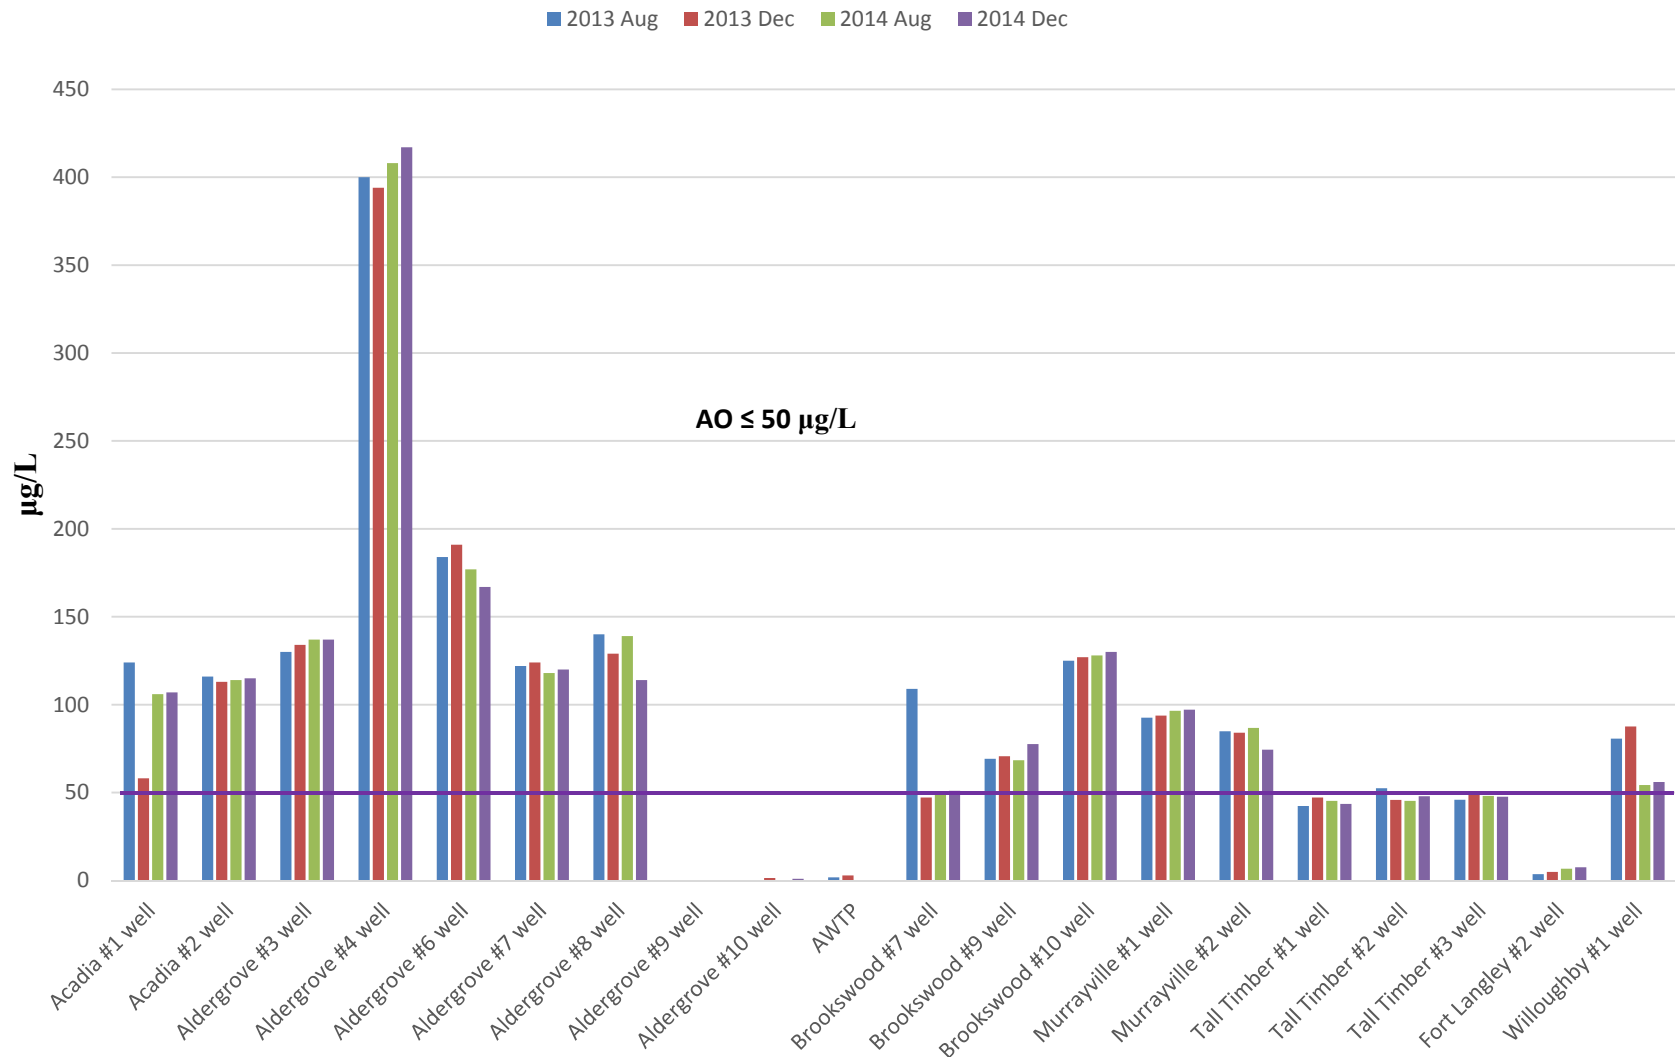
Figure A.9: Manganese

The aesthetic objectives for manganese were not met in 2014 for several Township water sources, including Acadia, Aldergrove, Brookwood, Murrayville, and Willoughby wells. Acadia services a very small community of 24 homes; options to reduce manganese concentrations, and meet the aesthetic objective of 0.05 mg/L at point of distribution, were reviewed in 2011. Polyphosphate sequestration was determined to be the best treatment option; however changing to Metro Vancouver supplied water from the ELWS was determined to be a better long term solution. Manganese levels at five of the seven Aldergrove wells were above the aesthetic objective, but were reduced to an acceptable level during the treatment process at the AWTP prior to distribution. Brookwood and Murrayville ground water sources are mixed with GVWD water, decreasing manganese levels to acceptable levels prior to distribution.

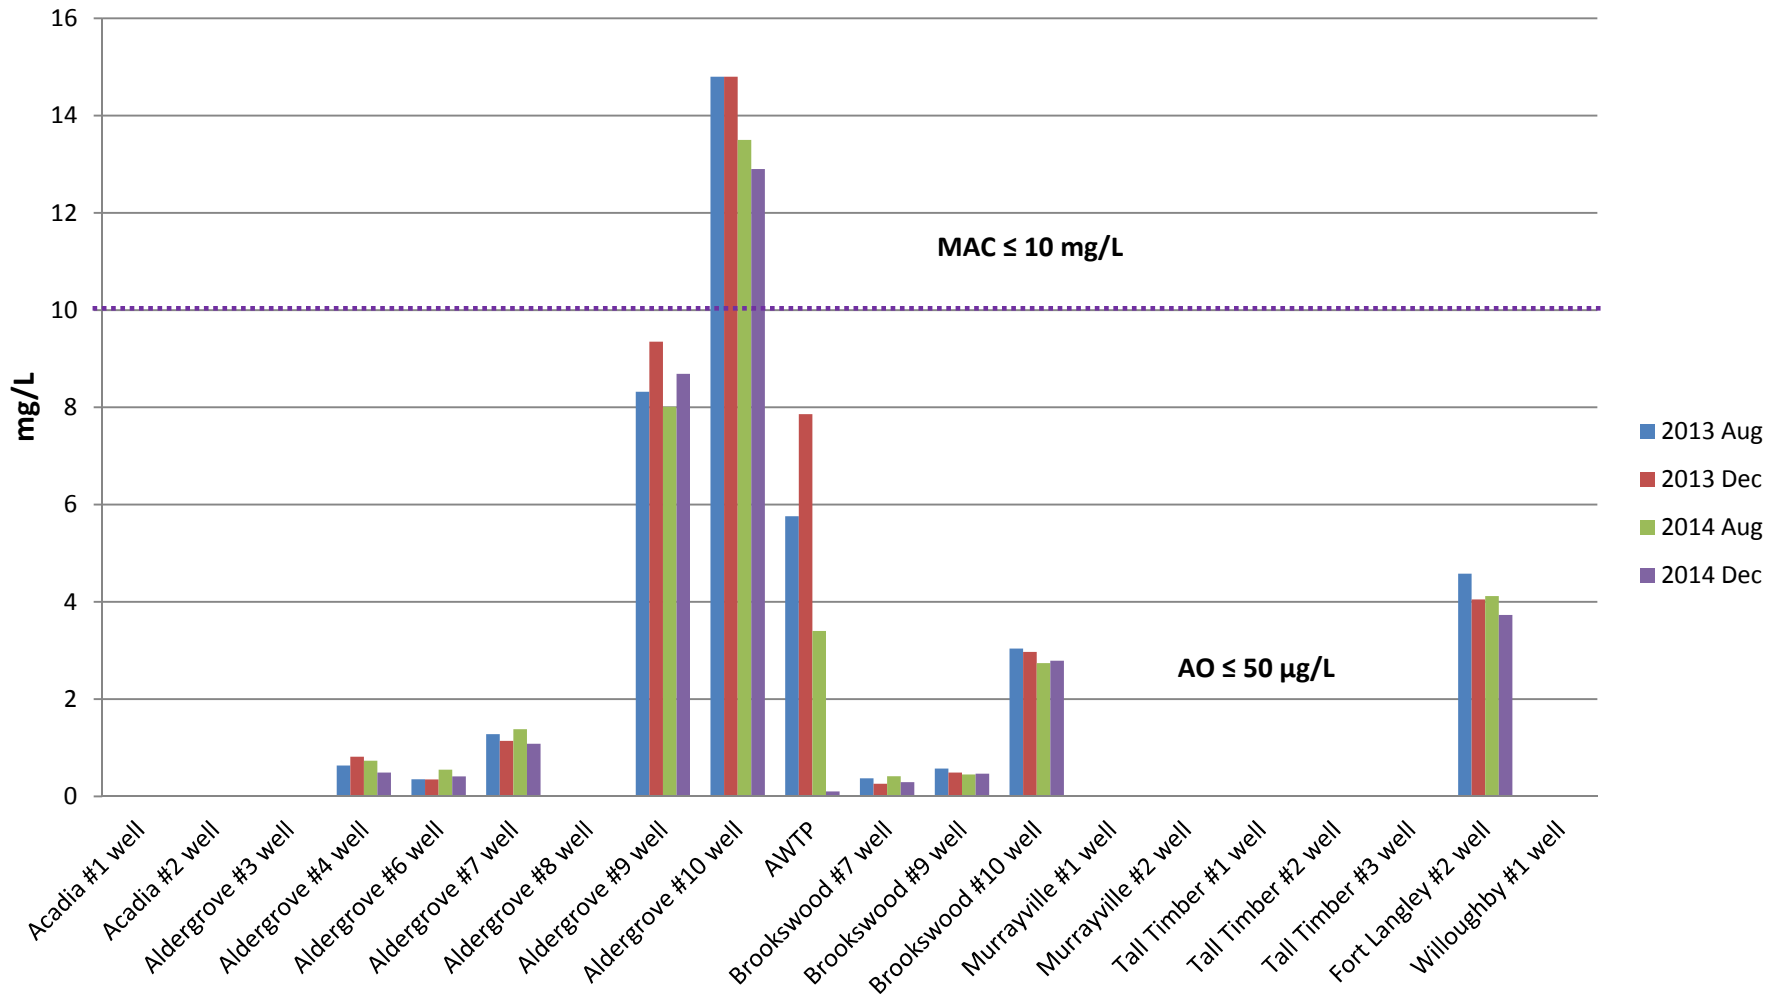
Figure A.10: Nitrate

Nitrate was above the allowable level of 10 mg/L at Aldergrove Well 10. With the approval of Fraser Health, prior to distribution, the Township blends high and low nitrate content water at the AWTP. The blending results in an acceptable nitrate level of less than 10 mg/L, measured weekly to ensure regulatory compliance.
